Success Story Metsä Board Äänekoski, Finland

Higher Customer Satisfaction and Line Efficiency with Procemex Web Inspection and Monitoring System

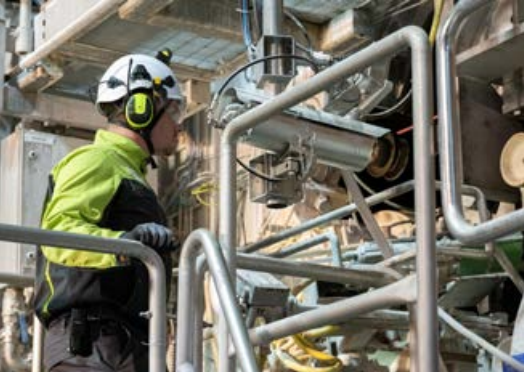
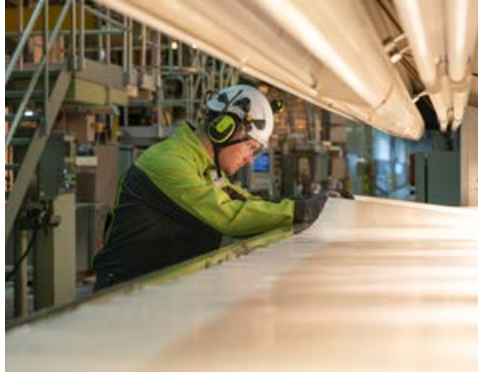
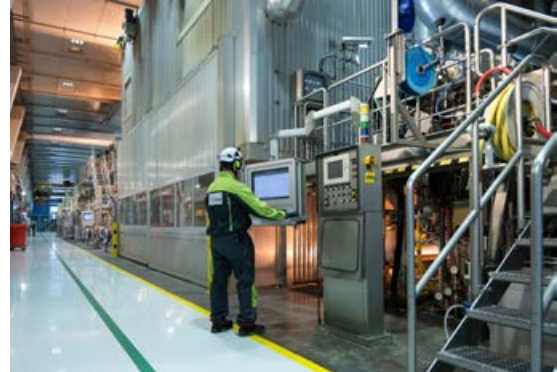
The folding boxboard is inspected at two distinct locations at the reel. Positioned steadily in mechanically stable carbon fiber Web Inspection frame, the cameras detect and classify coated product surface defects at 0,10 mm pixel resolution. "With the new camera technology, we can see coating blade streaks and other defects better than before," says Hirvonen.

The low-angle inspection geometry uses a 15 degree camera angle and a 15 degree illumination angle to provide a mirror reflection from the folding boxboard surface. This enables the detection of very small coating defects, such as streaks or coating skips.

The transmission detection is used together with the high-angle reflection detection. This unique two-profile measurement geometry with sequential illumination is used for detecting and classifying surface defects as well as defects inside the product. It provides a foundation for more advanced and reliable defect classification and root cause analysis.
